I. STATION-TO-STATION SCHEME

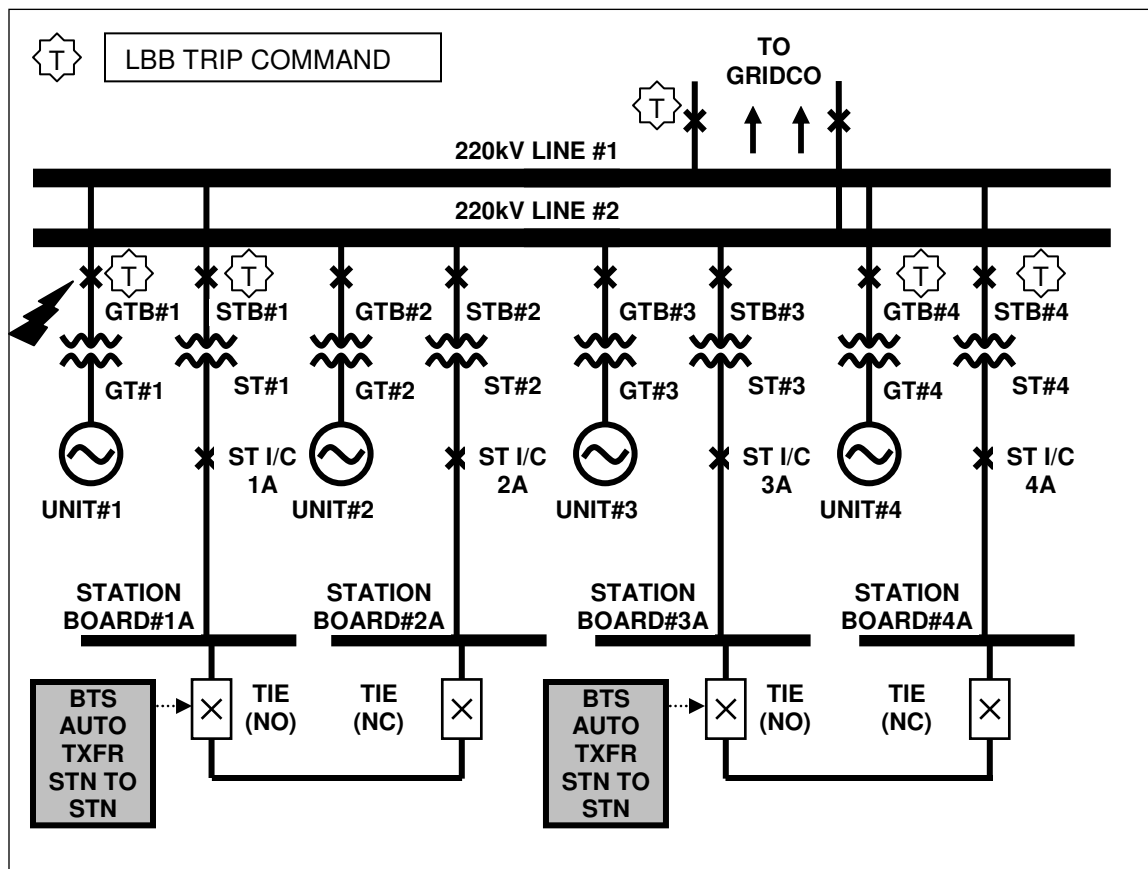
Fig. 8. 4x210 MW Thermal Power Plant – LBB Trip resulting in Unit & Station Board AC Failure

This case study is about an exceptional incident at Khaperkheda TPS consisting of 4 210 MW units (say Unit#1-4) had 2 units each feeding into separate 220kV lines (say Unit#1,4 – Line#1 & Unit#2,3 – Line#2). This installation was provided with automatic fast transfer schemes only for Unit-to-Station, and Manual-Only schemes for Station-to-Station fast bus transfer.

Incidentally, the Station Transformers ST#1,4 for Unit#1,4 were also connected to Line#1, and ST#2,3 for Unit#2,3 were connected to Line#2 which is not a standard

practice in the interest of redundancy. Unit#1 was being withdrawn for shutdown, when its Generator Transformer Breaker (GTB#1) mal-operated and did not trip. This resulted in an LBB condition on the Line#1, tripping all the feeds from that line in the plant, which included GTB#4 for Unit#4 (operating at full load) along with STB#1, 4. Protective logics immediately initiated a Unit-to-Station transfer for Unit#1, 4; which successfully transferred Unit#1,4 unit boards to ST#1,4 respectively.

However, this was not of any use since ST#1, 4 had also lost its incoming feed from Line#1. The backup DG Supply also malfunctioned and failed to startup. Thus both Units#1,4 suffered total AC Failure. Had there been an automatic Station-to-Station Scheme, the station boards fed from ST#1, 4 could have transferred to ST#2, 3 avoiding this condition.

As a matter of fact, Unit#4 suffered station battery bank failures for both its backup DC supply banks due to the sudden surge in load, and the DC Jacking Oil Pump (JOP) also lost supply within a few minutes of this event leading to severe damage to its turbine bearings and several months of unit outage. Automatic station-to-station bus transfer schemes are thus recommended for this plant.
