CASE STUDY

O.P. JINDAL TPS 4x250 MW

STATION-TO-STATION MANUAL TRANSFER FAILURE ON 18/10/2007

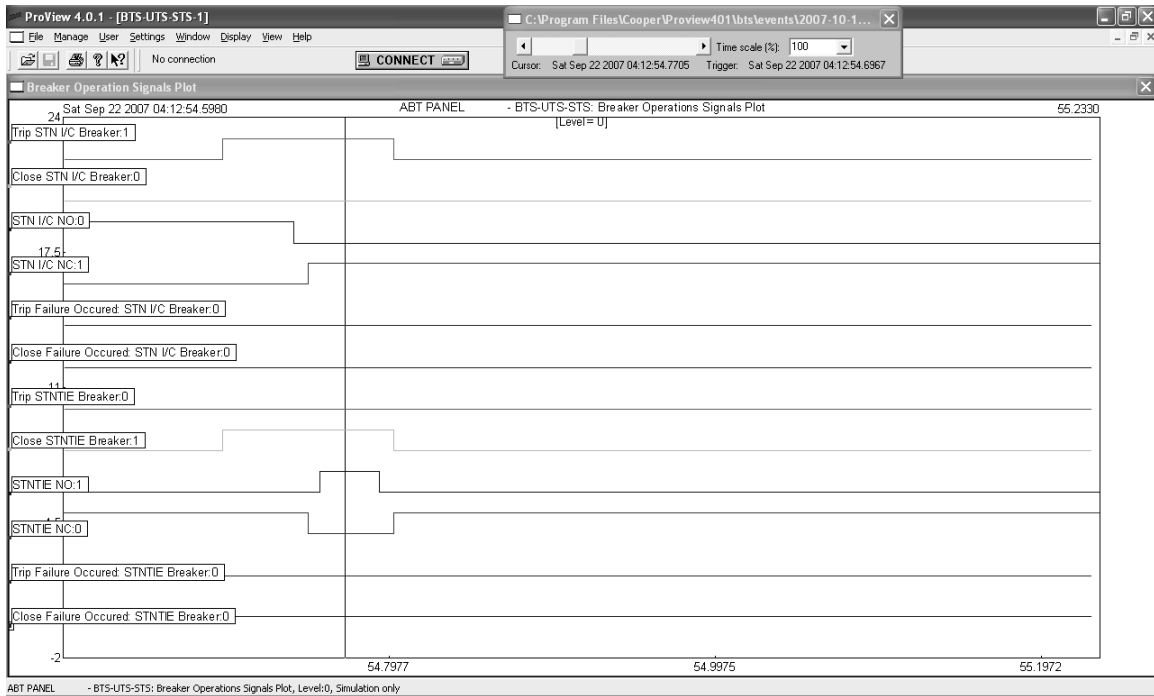
Fig 1: STS Oscillography – Breaker Operation Plot

RLSR05 TIE closed and then tripped after 60ms approx.

Electrically, the bus transfer (breaker trip and close operations) happened normally. However the breaker failed to latch after closing and tripped immediately after closing. Reference is drawn to similar event of breaker not latching observed during commissioning. Mechanical trip (eg emergency trip) may be operative on the breaker – the mechanical adjustments of which may have got disturbed.

This shows Tie Breaker turning ON (NO/NC contact changeover) and tripping within 60 ms.

Breaker maintenance and detailed check-up for trip-close operations. Repeated (10's to 100) trip/close operation on the breaker should be carried out under maintenance to check for repetitive nature of this problem.

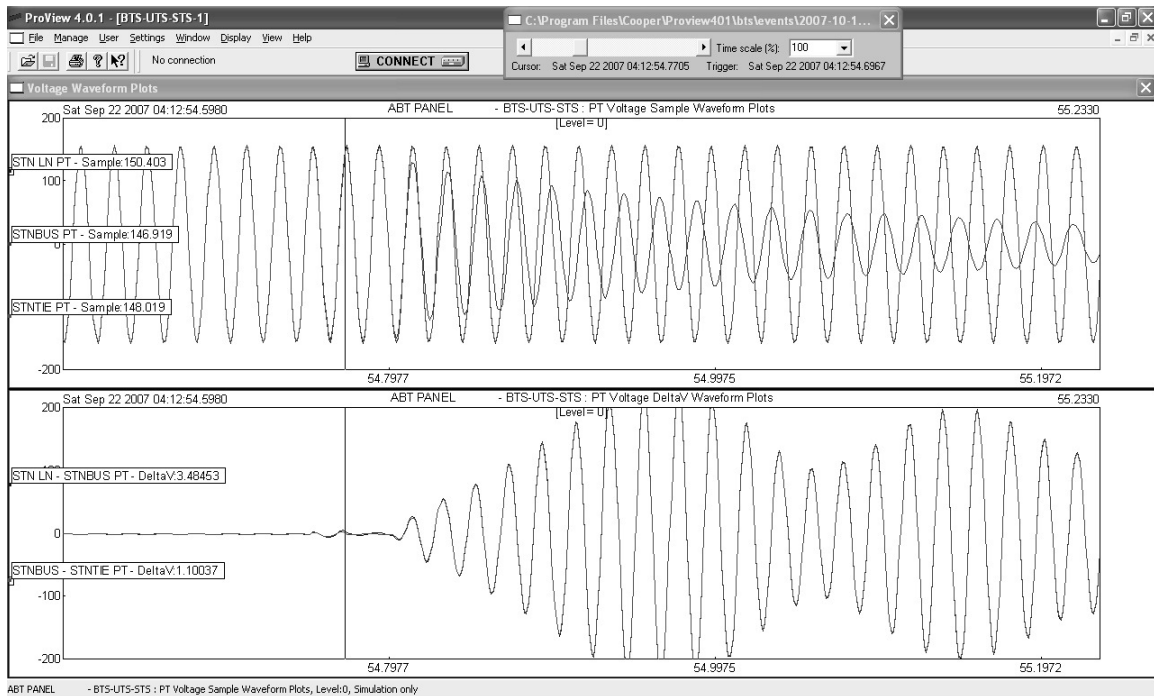
Fig 2: STS Oscillography – Voltage Waveform Plot

This shows Station Bus PT getting charged from Alternate Station Bus through successful fast transfer, and then getting disconnected – resulting in spin-down characteristics of the bus.
